IP68

FOR
Flash Drive

TEST REPORT

EUT Type: Flash Drive

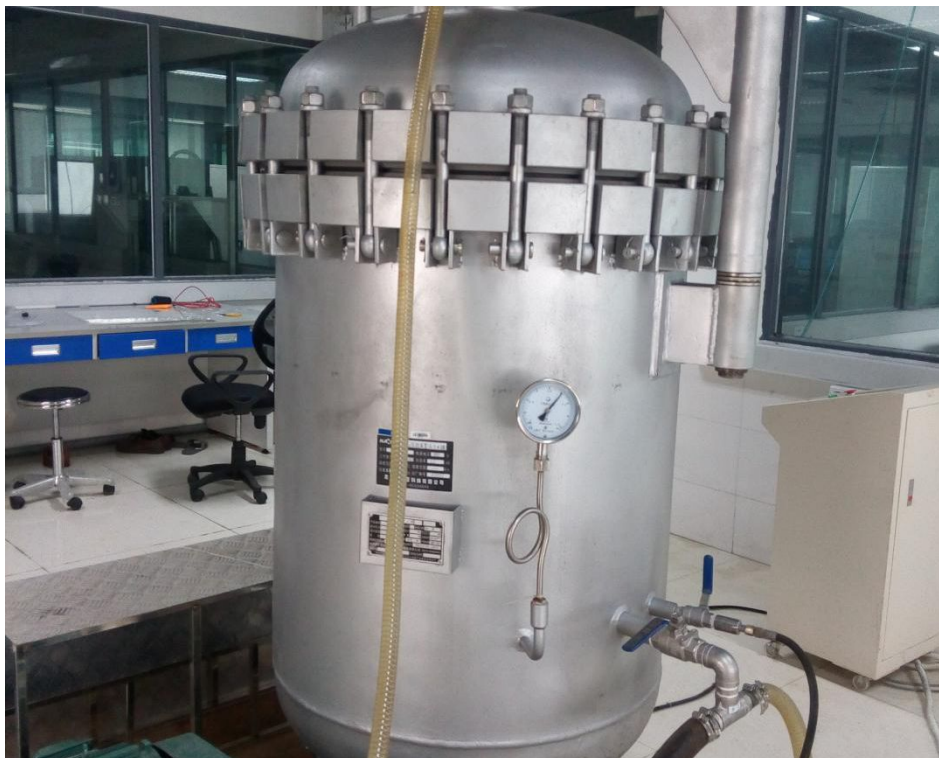
Test arrangement Photo

1. The pressure inside the chamber is equivalent to that of 100m underwater submersion.
2. The duration of the test is 60 min.
3. The water temperature does not differ from that of the equipment by more than 5 K. However, a modified requirement may be specified in the relevant product standard if the tests are to be made when the equipment is energized and/or its parts in motion.

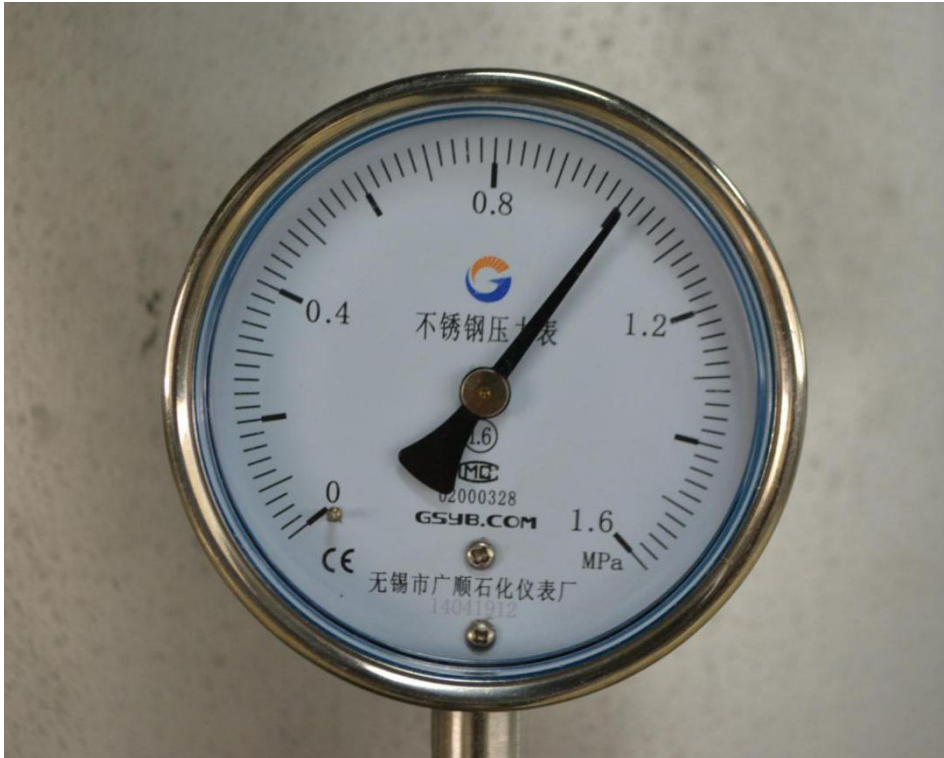
Test photo

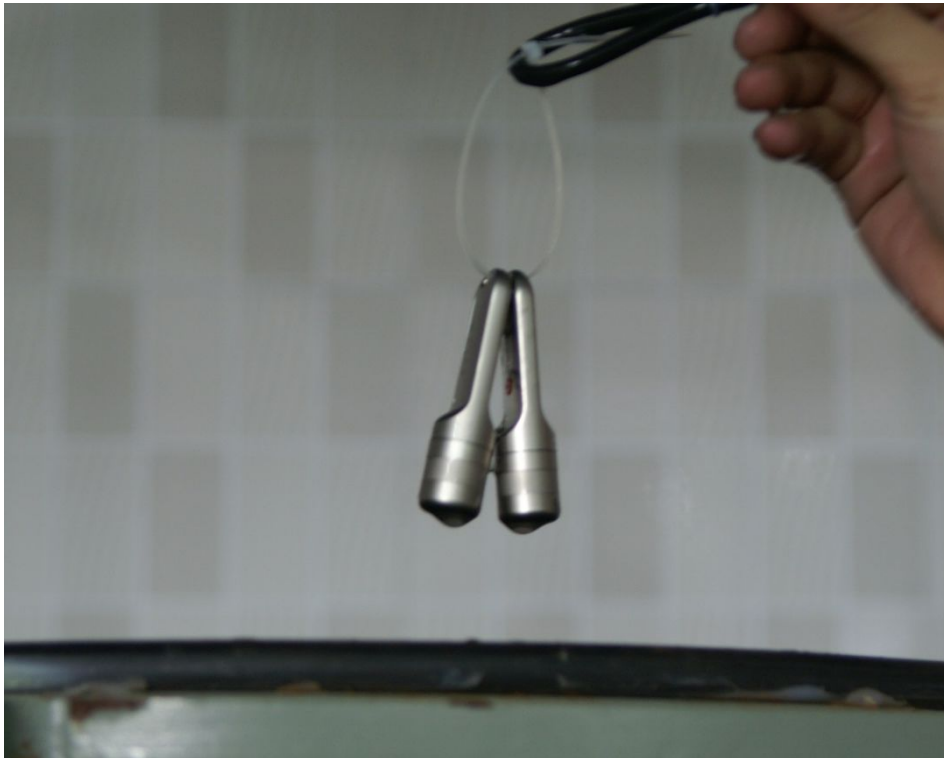
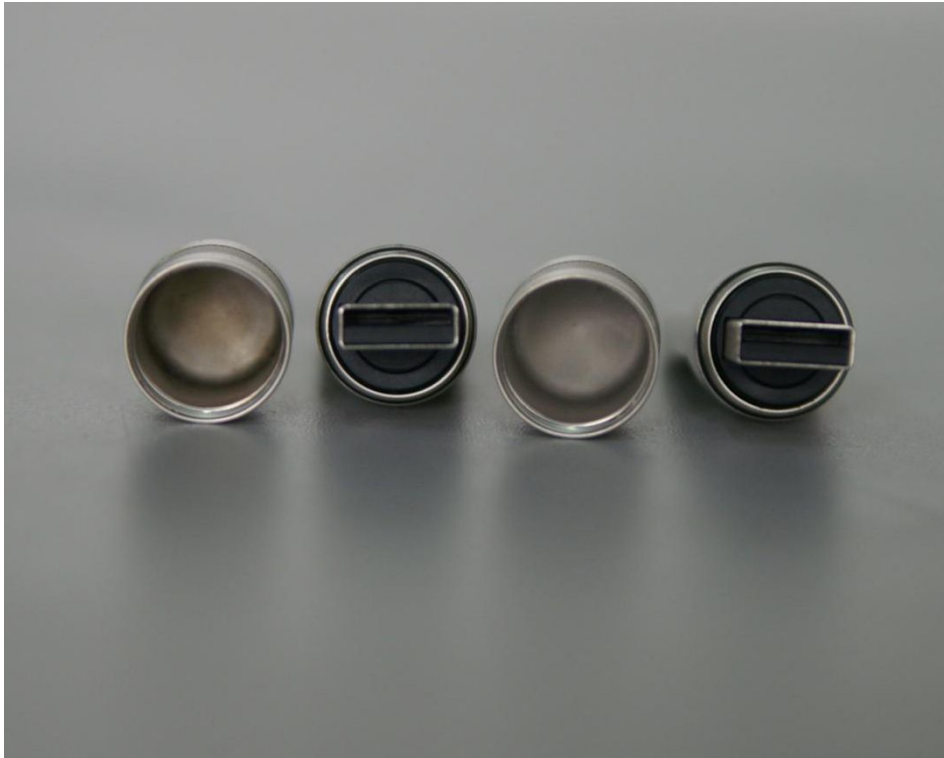
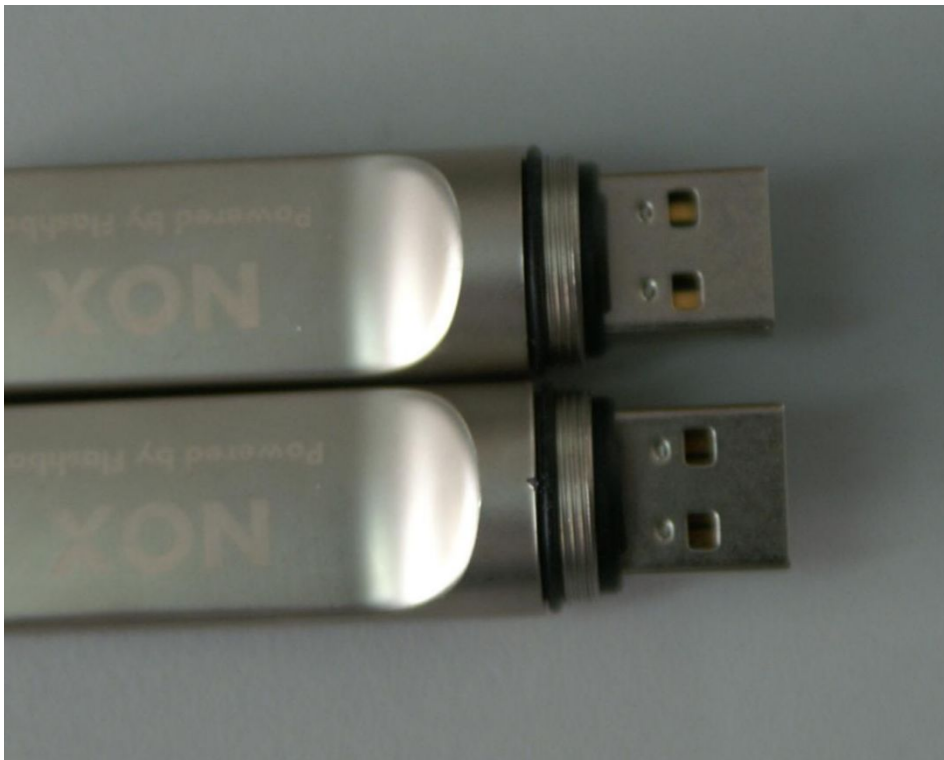
Validation after test

| test item | test outcome | verdict |
|---|---|---|
| IPX8 | There is no water found inside of the sample, the sample works normally as usual. | Pass |
